① BUREAU OF SHIPS GROUP
TECHNICAL INSPECTION REPORT

(6) OPERATION CROSSROADS.

FAILURES OF MASTS, YARDARMS,
BOOMS AND RIGGING [U.]

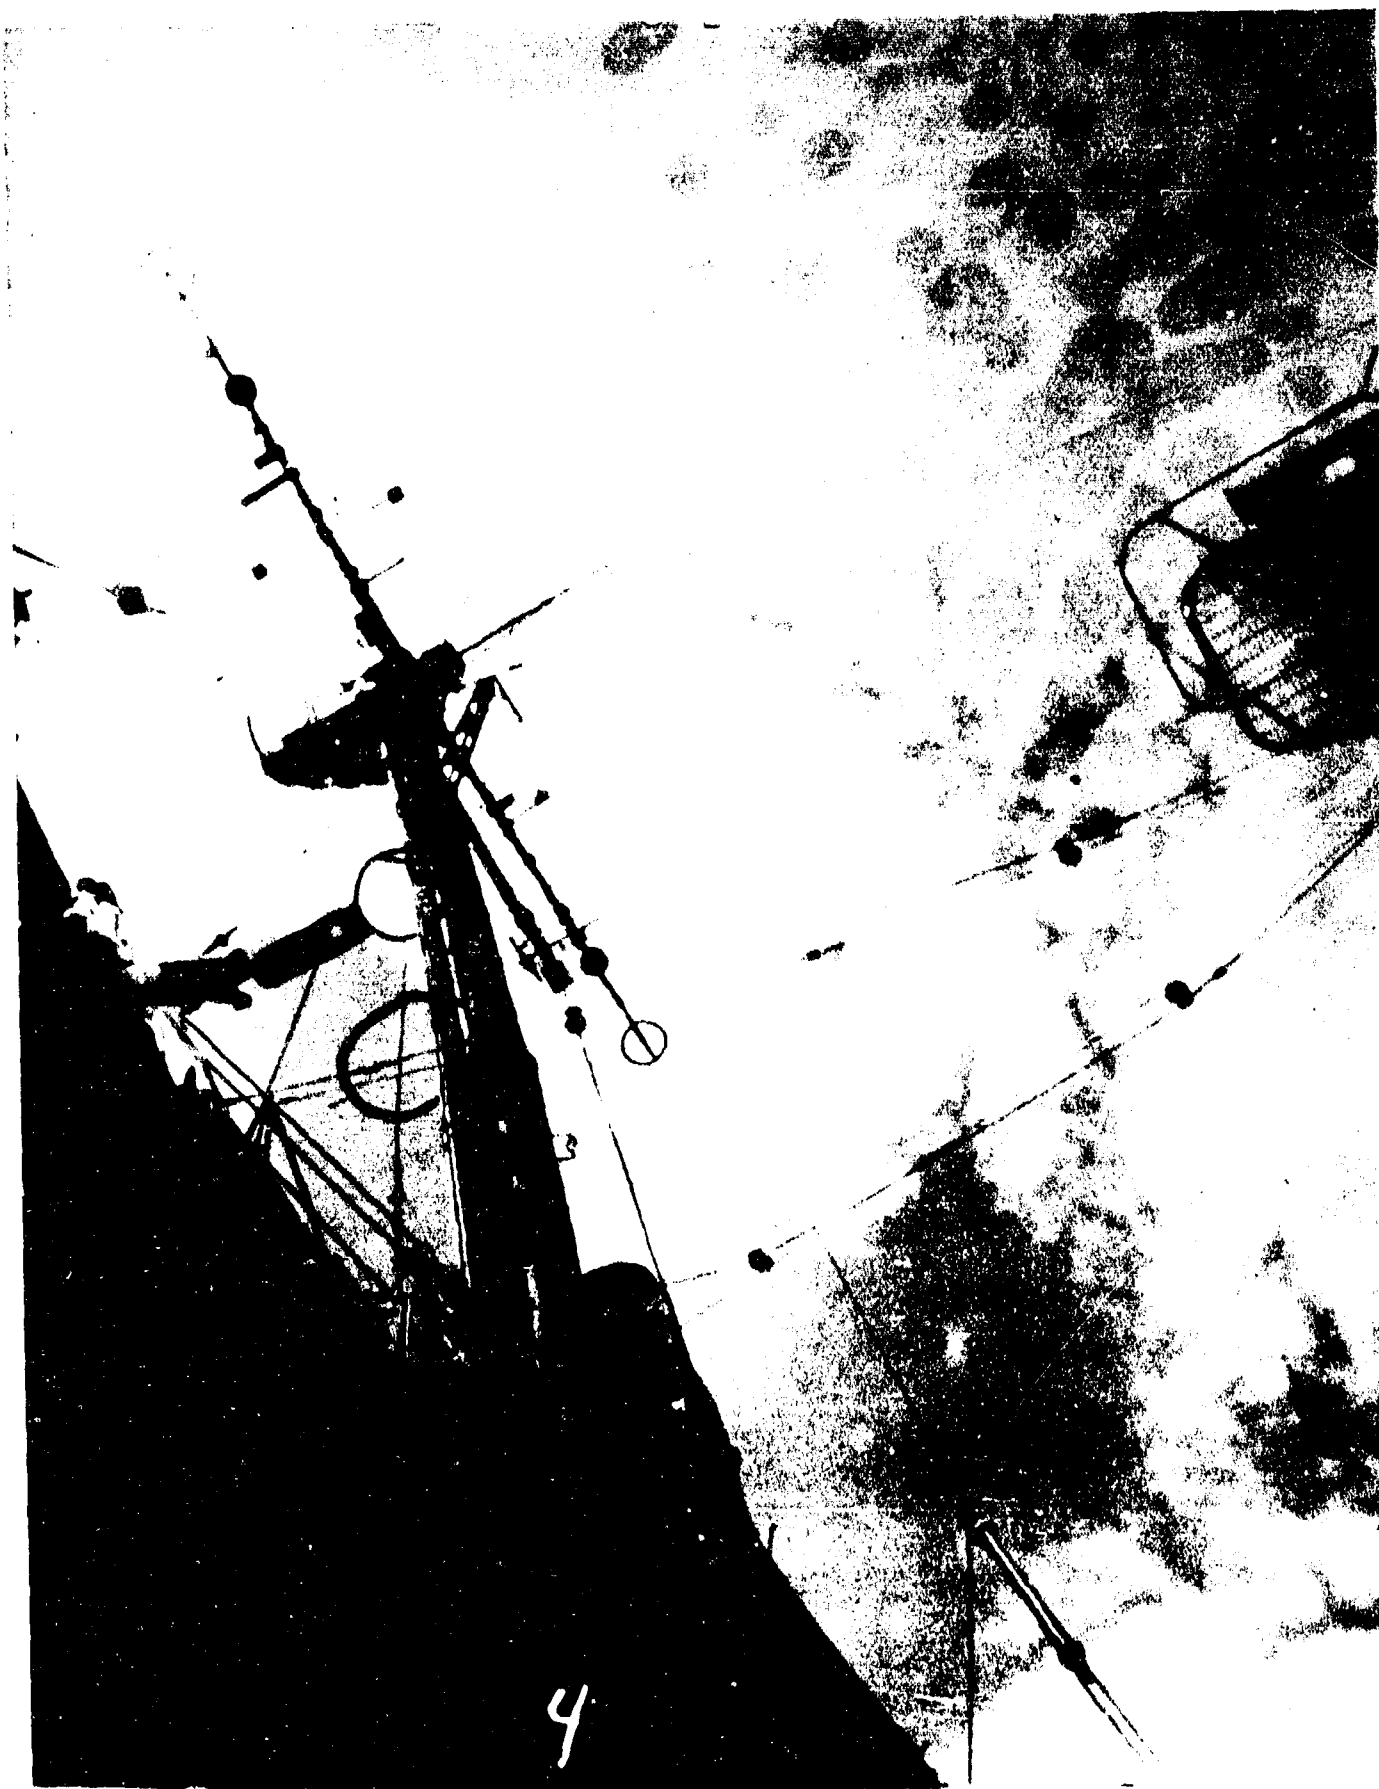
AA-CR-100-2198-4. U.S.S. HUGHES (DD410). View looking to starboard and up at foremast.

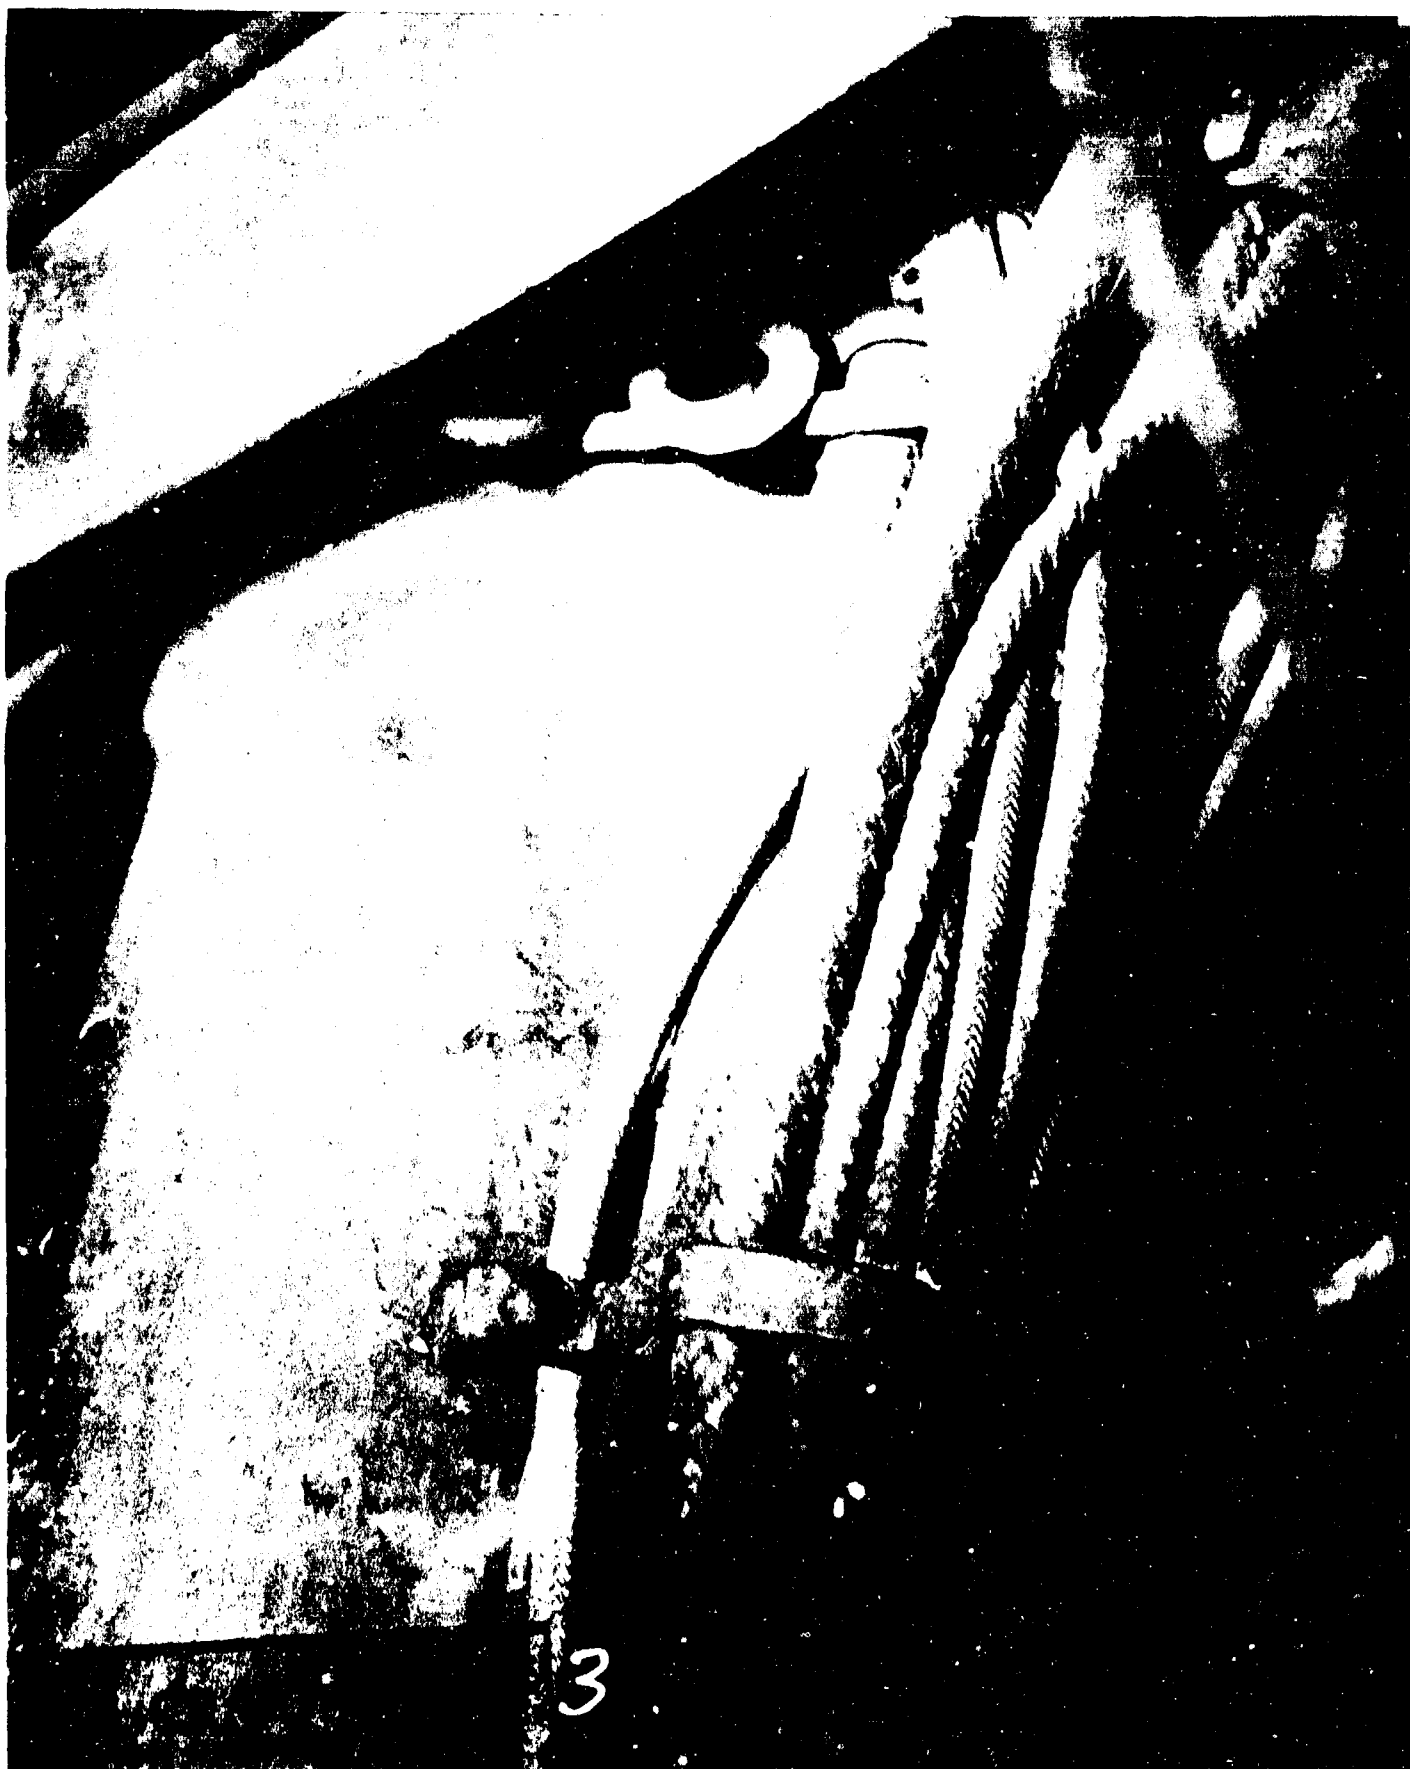
AA-CR-100_2198-3. U.S.S. HUGHES (DD410). Detail - after side of foremast.

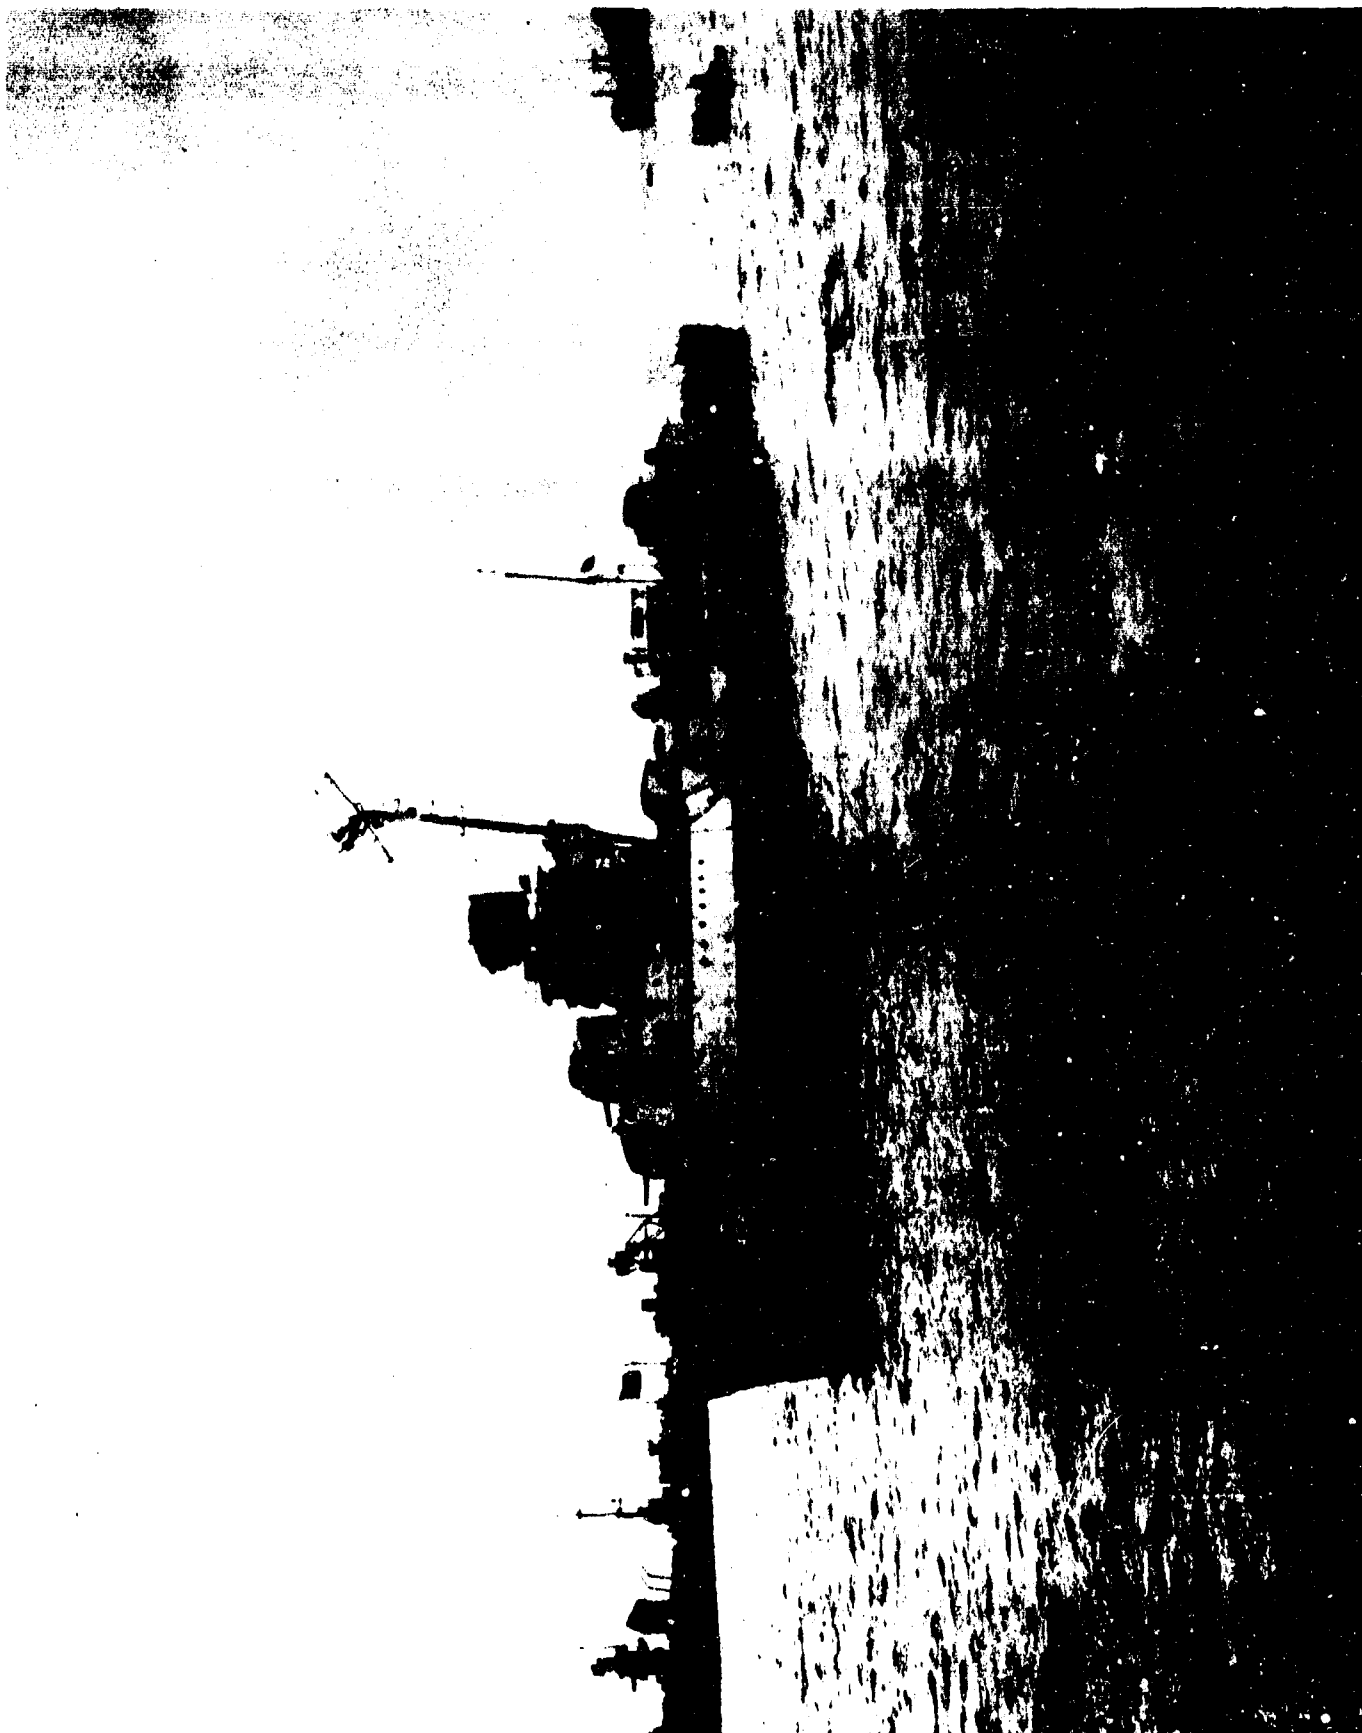
2. Photos 196-156-1, 227-49-137, 227-283-58 and 227-520-42; pages, 184, 185, 186, and 187 are comparative views before and after Test A. In photos 227-283-58 and 227-520-42, pages 186 and 187, it appears that while the foremast and mainmast have been bent in the direction of the blast, the head of the foremast has been bent into the blast. Investigation showed that the foremast is cracked just below the yard. The position of the yardarm is relatively unchanged with respect to the upper portion of the mast which is askew to the main body of the mast. Radar on the starboard yardarm are gone but the upper stays are intact. All strand antennae are down and whip antennae are bent or broken. The main body of the foremast is about 10 degrees out of its normal position. The foremast is about 10 degrees out of its normal position. The foremast wave guide is twisted around the breakdown lights. There are bends, kinks nearly, in the foremast just above the padeyes to which the lower mast guys were secured about 12 feet above the brackets connecting the mast to the main deck. There are similar bends just at the tops of the brackets. The two 3/4 inch wire lower forward guys parted about 20 feet from the lower end. The remaining guys on this mast have approximately 14 inches slack. Photo 2200-9, page 188 shows the rigging and antennae still remaining and indicate that most of it is slack. Photo 2200-2, page 189 shows breaks in the cable guards at the navigating bridge level. Photo 2200-1, page 190 shows the frayed end in the lower portion of the starboard lower guy.

AA-CR-227-49-137. U.S.S. RHIND (DD404). View looking at port bow after Test Able.

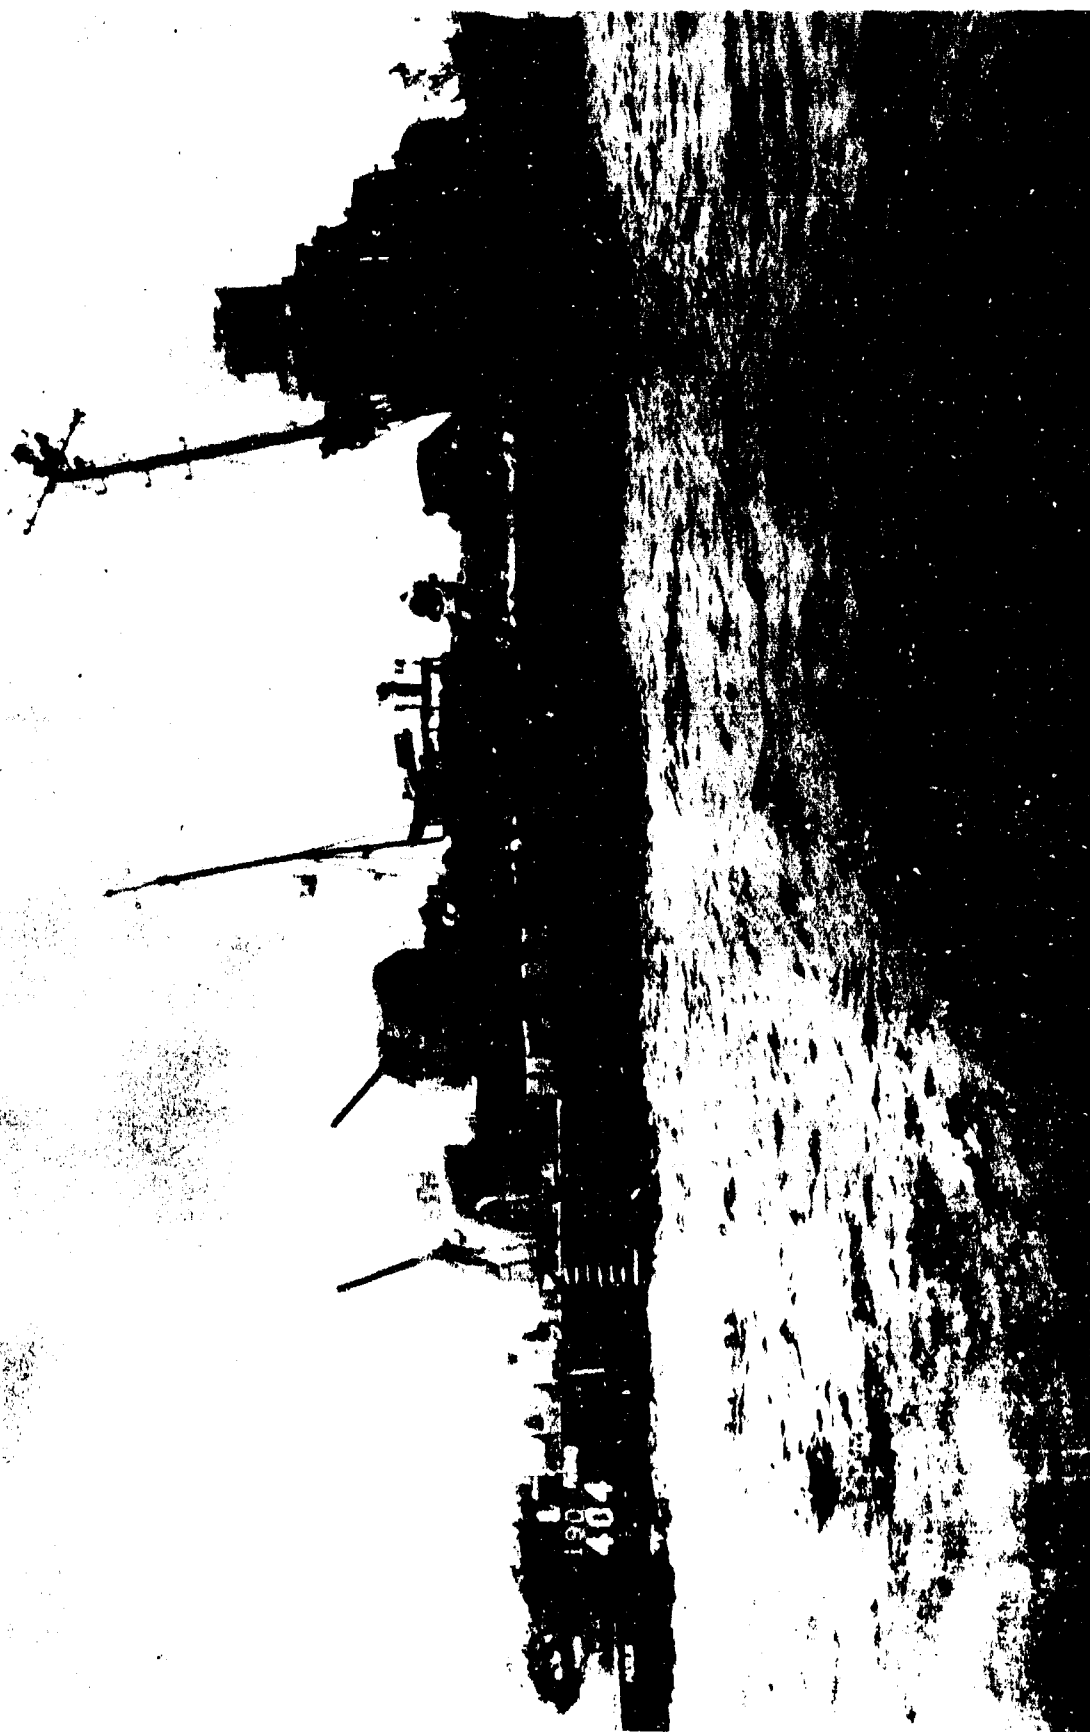
BB-CR-227-520-42. U.S.S. RHIND (DD404). View looking at starboard quarter, after Test A.

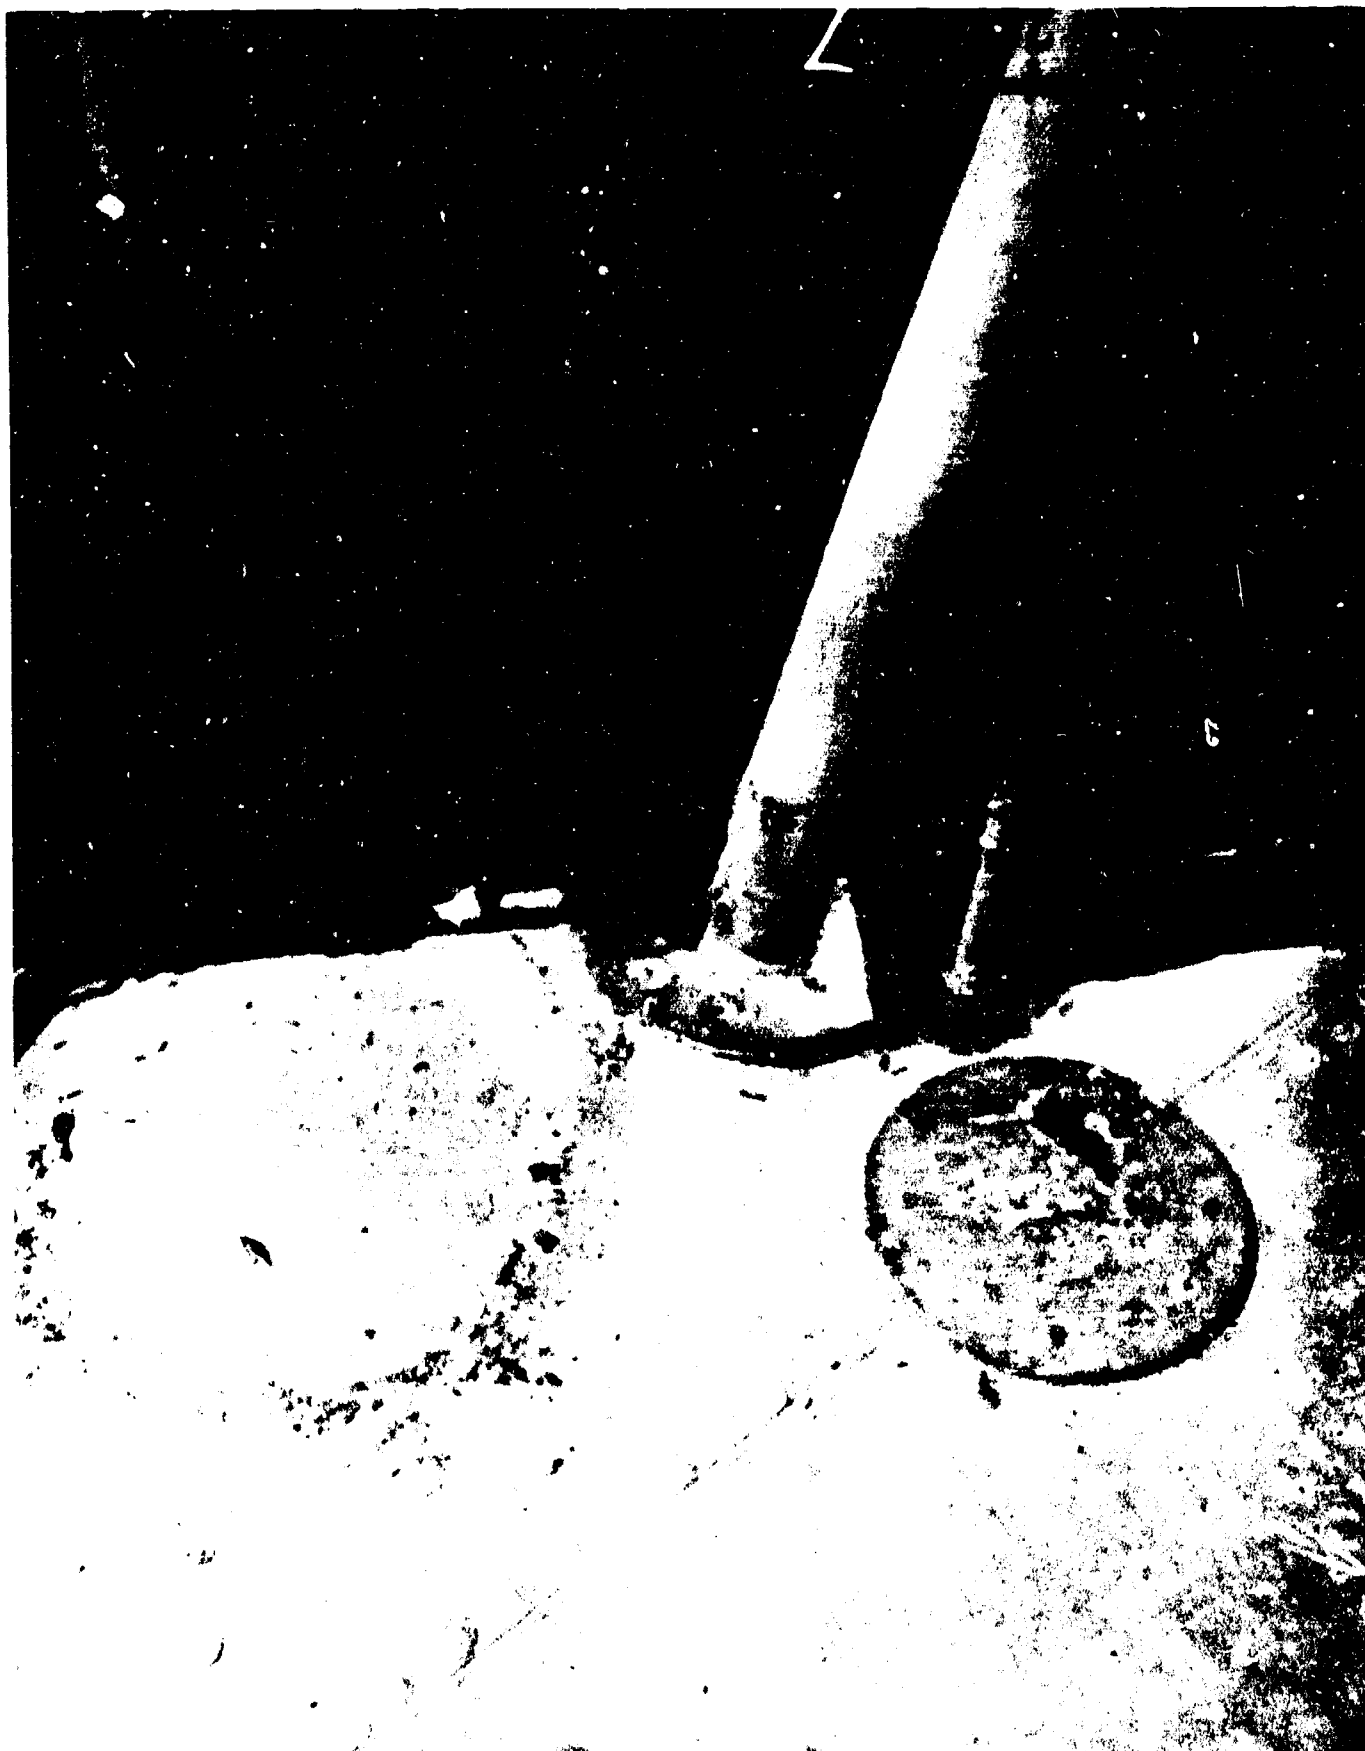
AA-CR-100-2200-7. U.S.S. RHIND (DD404). Base of after strut to after tripod.
